Swanton Railroad Station

Swanton, Vermont

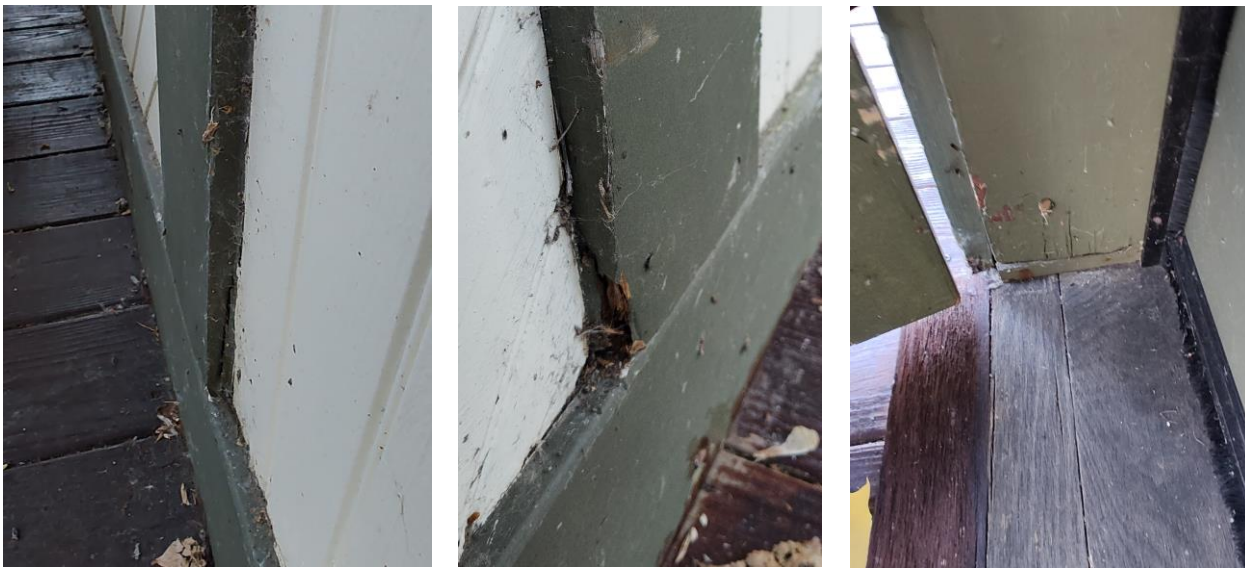
Views of existing rotted trim that needs to be replaced. New replacement to match existing.

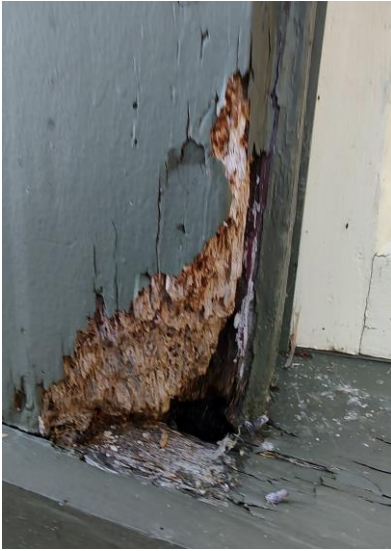
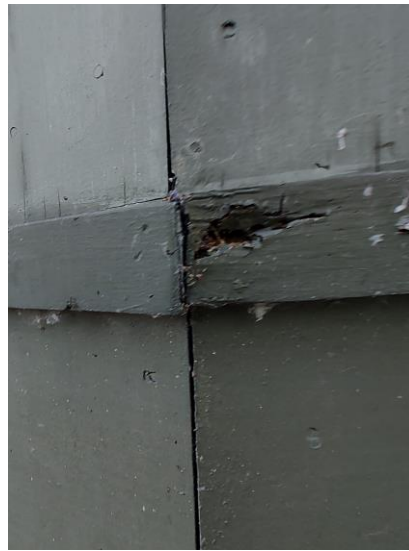
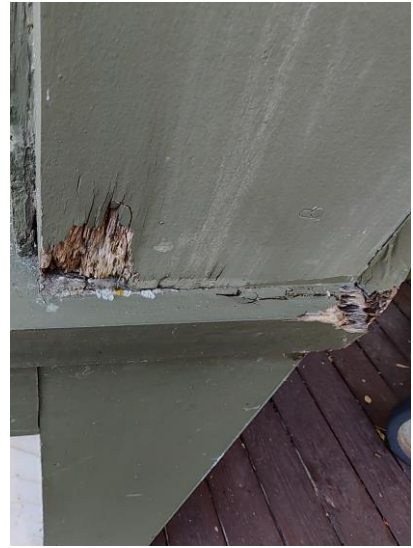
Views of existing rotted trim that need to be replaced. New replacement to match existing.

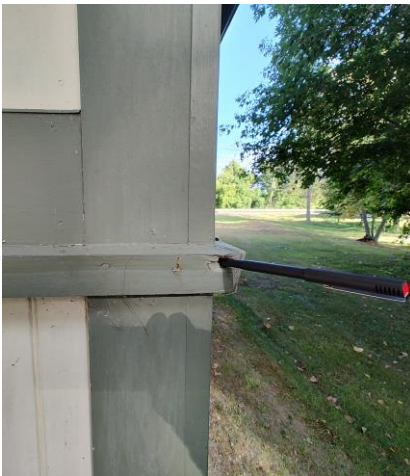
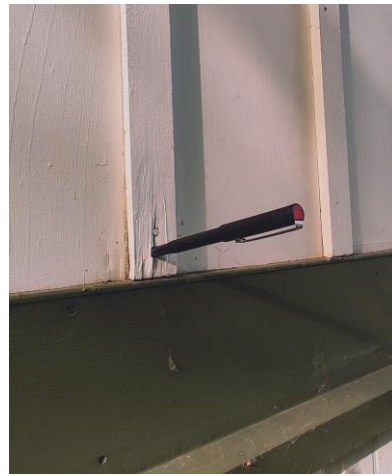
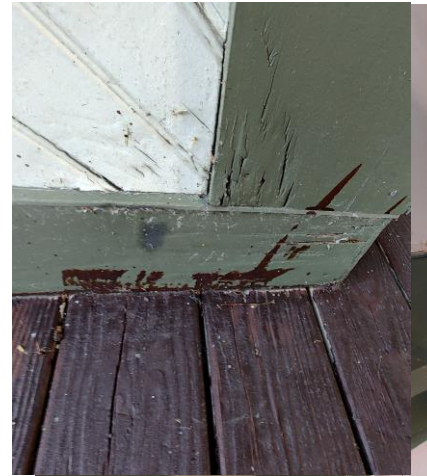
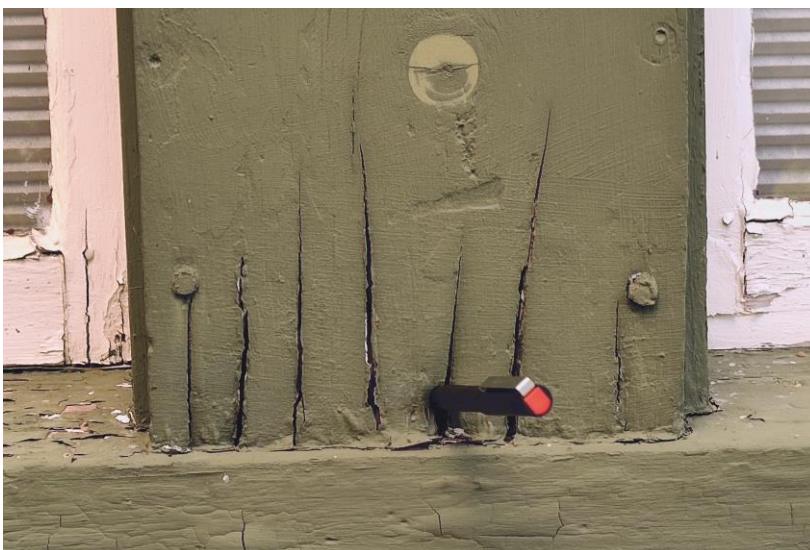
Views of existing rotted trim that need to be replaced. New replacement to match existing.

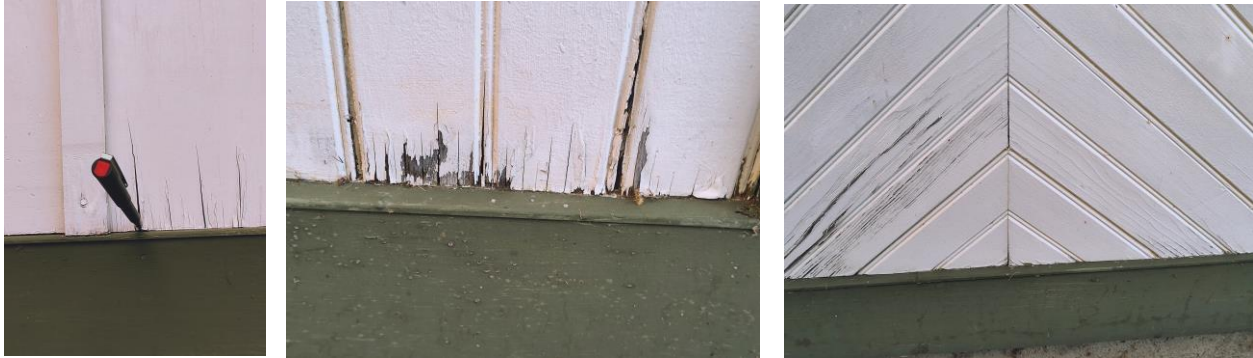
Views of existing cracks at the ends of existing trim boards and panels. New replacement to match existing

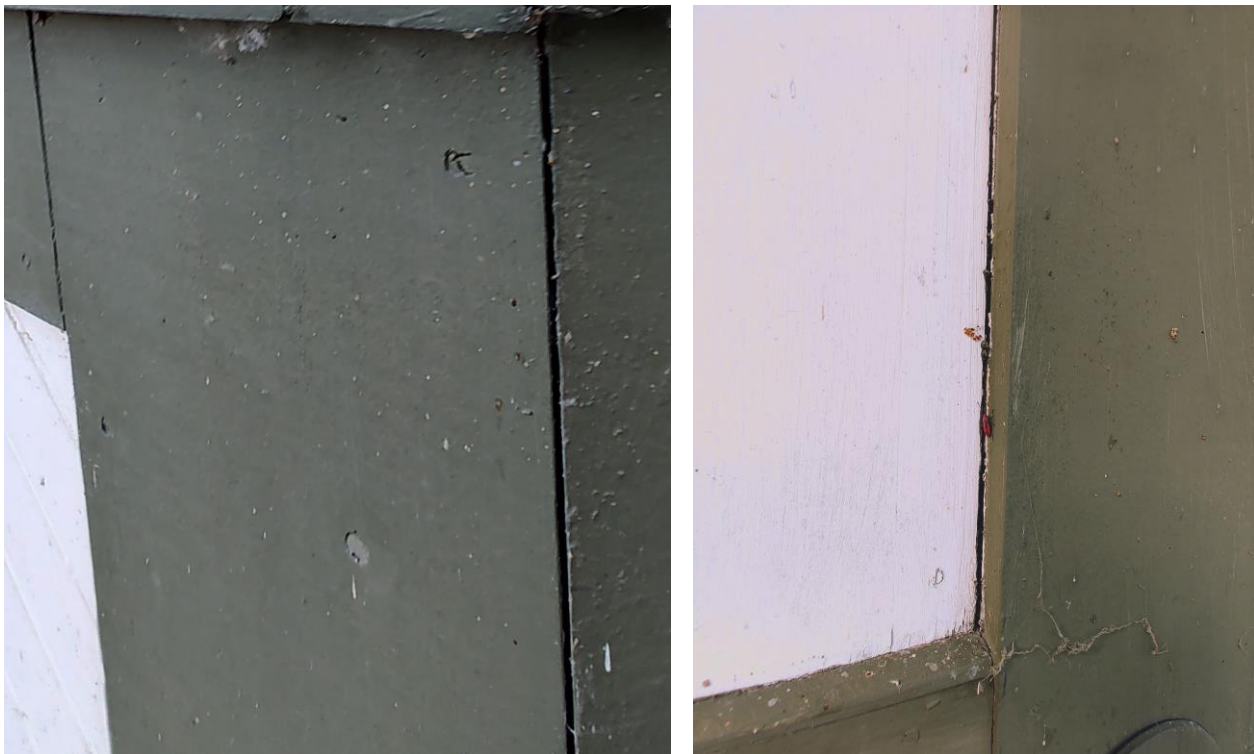
Views of existing gaps where existing trim boards meet and gaps between panels and trim boards.

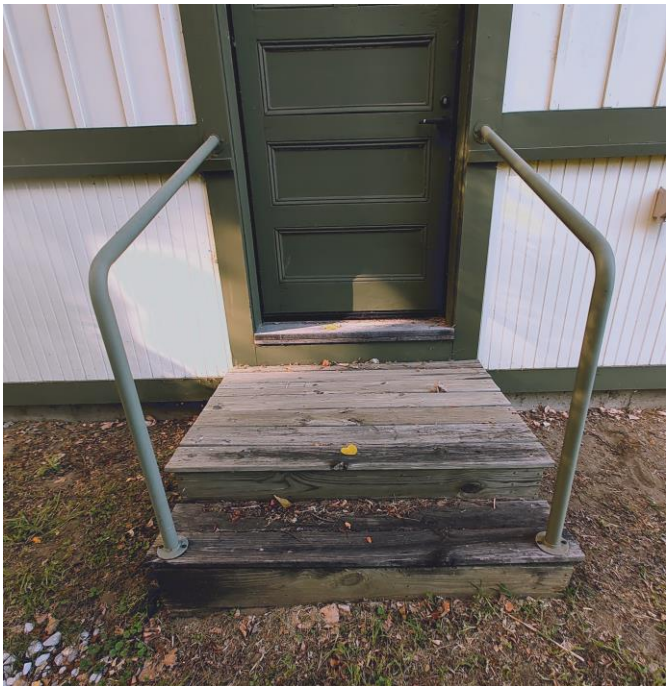
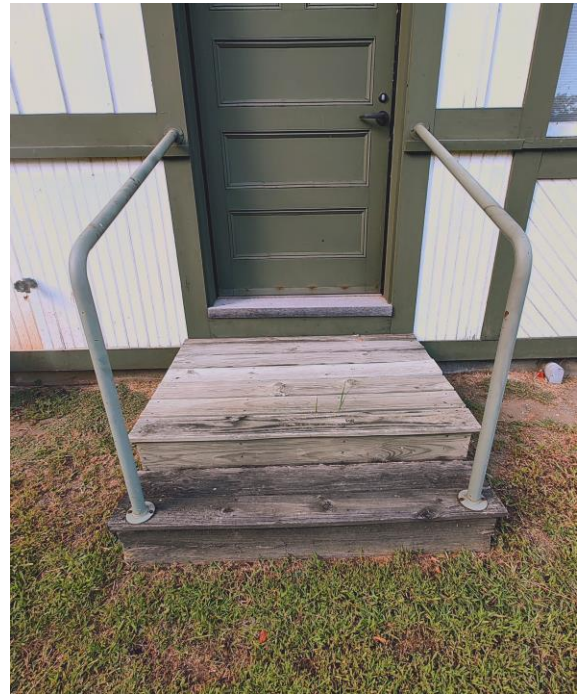
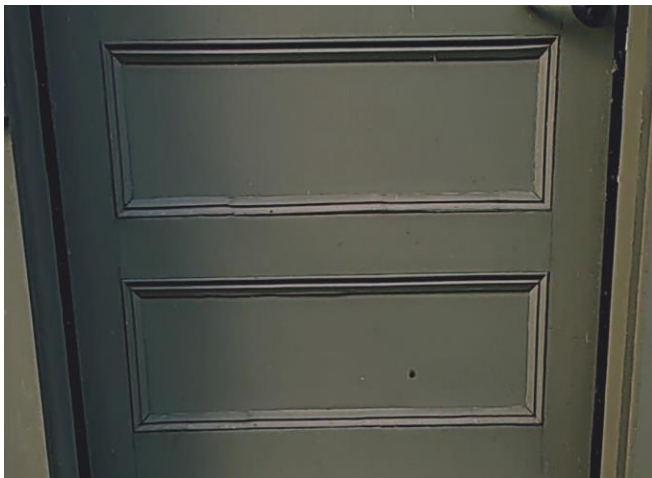
At some existing doors, molding at the panels have moved.

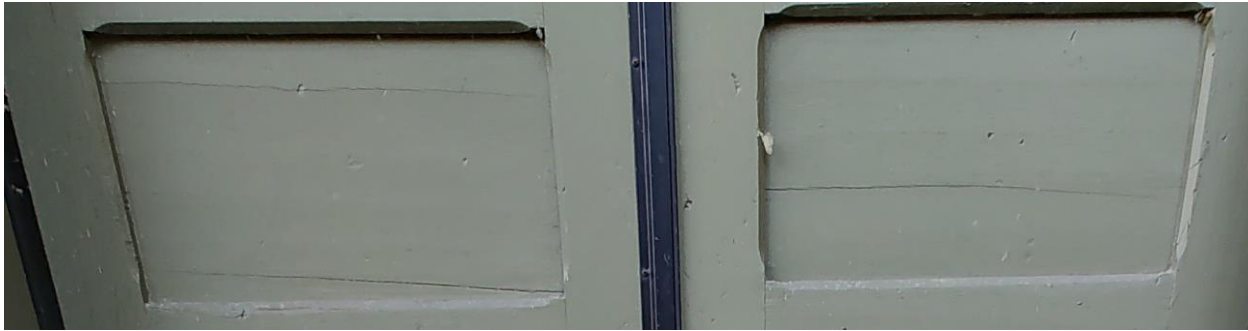
At some existing doors, the existing panels have begun to crack.

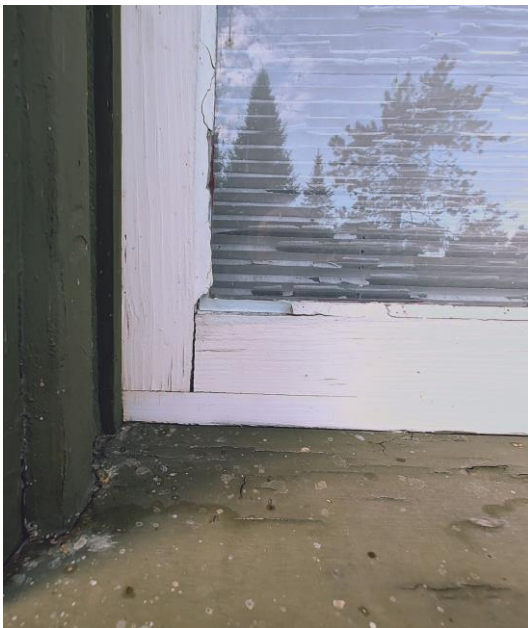
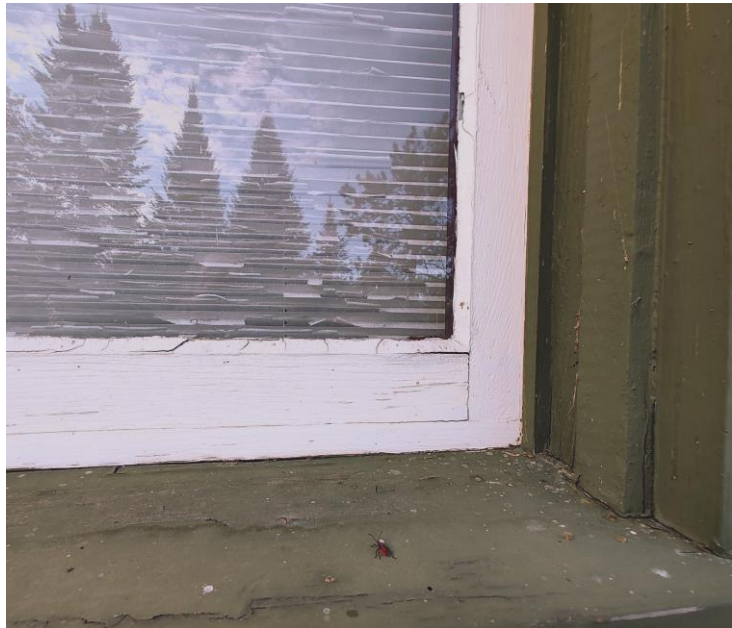
In our 2011 report, we stated that “There are two gables on the south and north sides of the building that have decorative wood scroll work. These scrolls are located at the face of the gable and have little protection from the elements. Joints and trim boards are beginning to separate. Some board ends are showing cracks and some elements have begun to separate.” It appears no work was done to the scroll work, which is unfortunate.

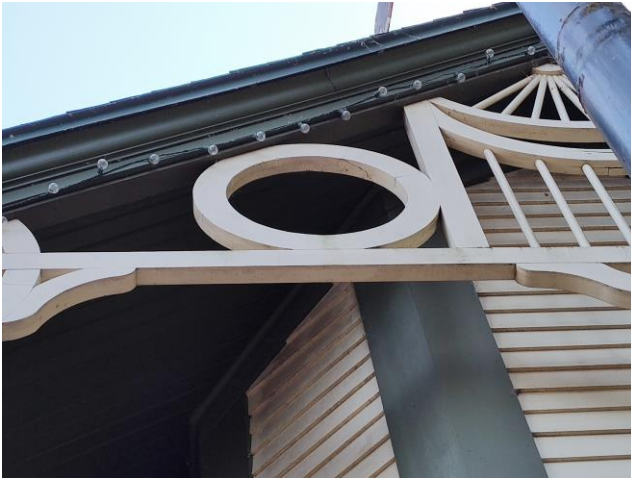
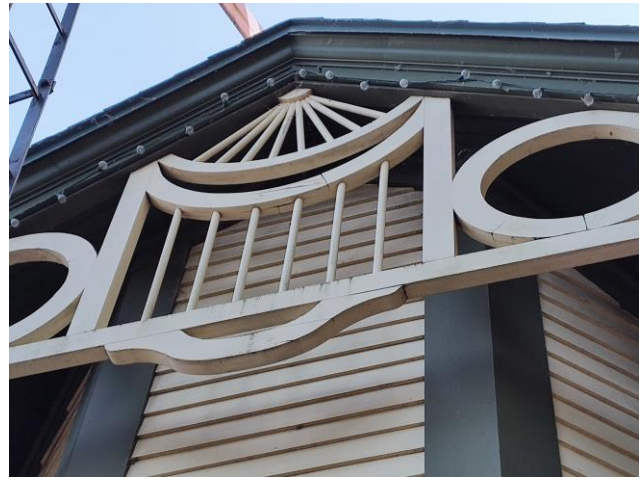
At the north scroll, rot has begun at some of the trim pieces. They will need to be removed and new trim pieces install. New trim pieces to match existing.

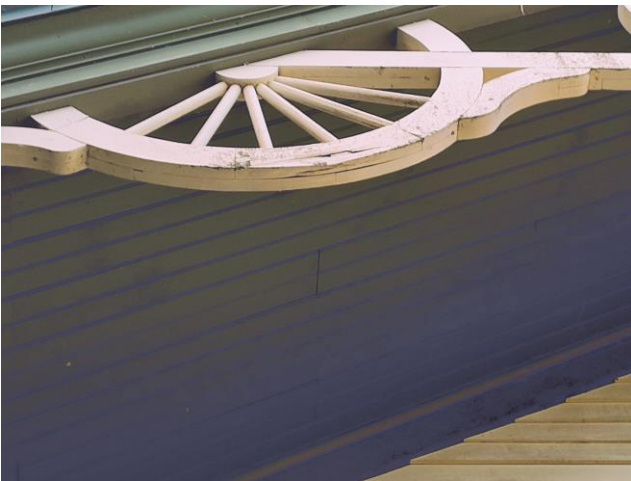
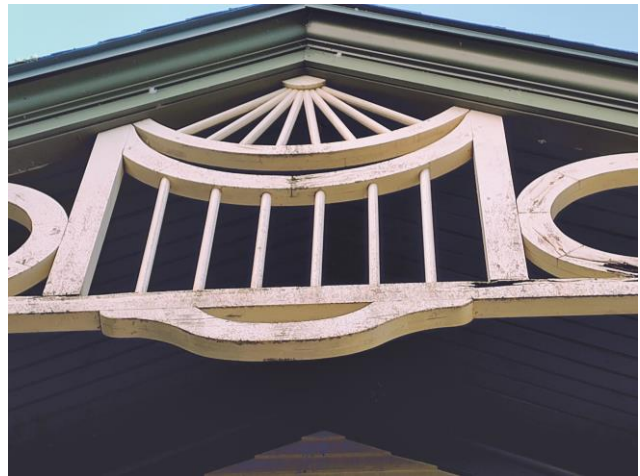
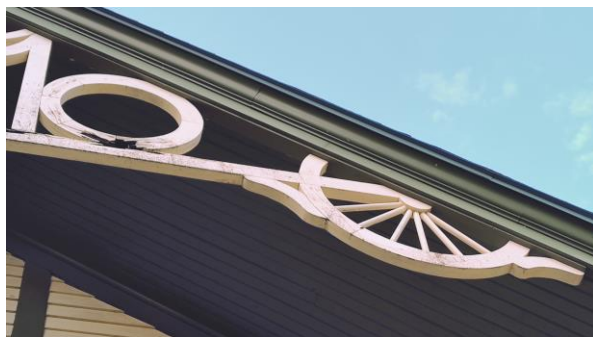
Now, the existing south scroll work has major rot at some of the trim pieces. The rotted pieces will need to be removed and new trim pieces install. New trim pieces to match existing. The existing surfaces of both scrolls need to be cleaned (using TSP-PF), exterior surfaces to be scraped to remove loose and/or failing paint, sand, prepped for painting, spot primed, joints caulked/sealed and apply two finish coats paint.

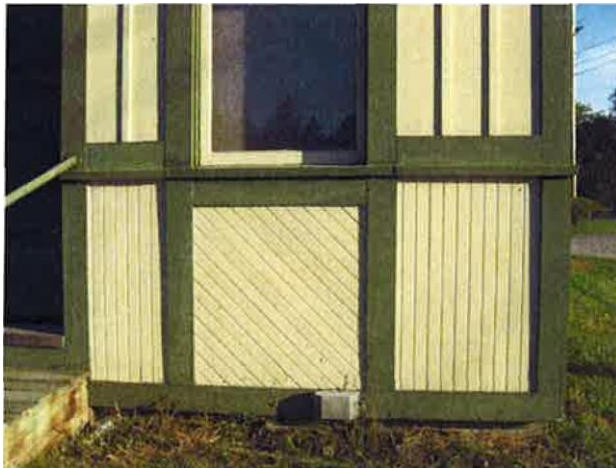
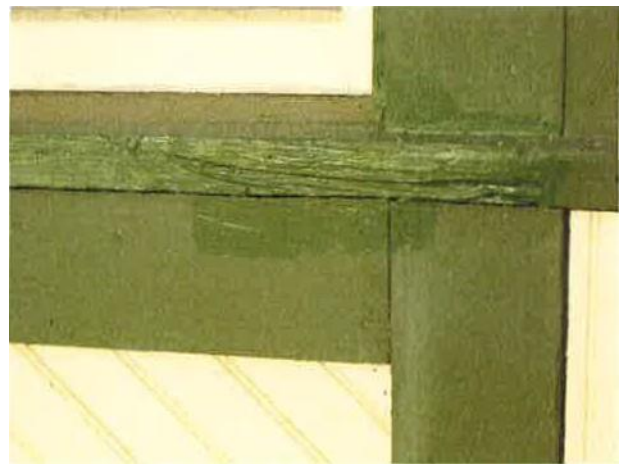
Renovation work to the Swanton Railroad Station was completed in late 2002. The Station exterior appears to have held up well. While there are no signs of deterioration, there are areas on the exterior that are beginning to show wear, especially on the south and east sides of the building. These sides of the Station are mostly in the sun during the day and the paint has begun to fade.

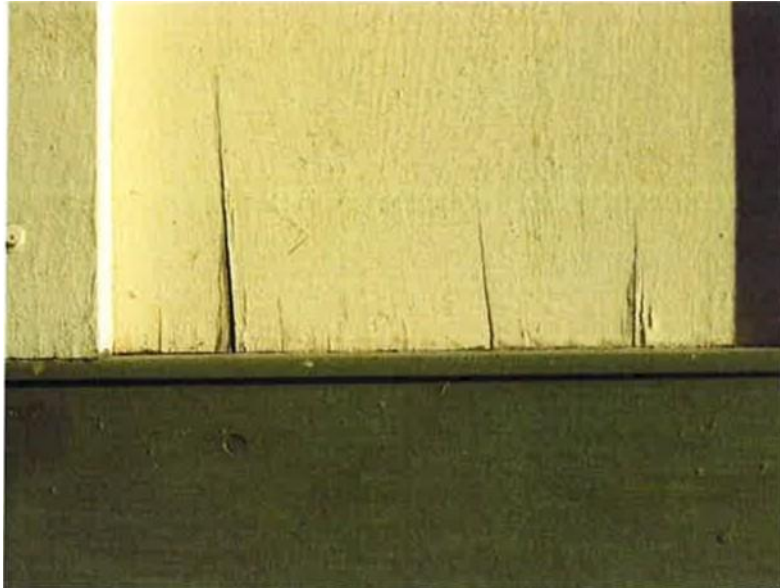
Painted Wood That Has Cracked

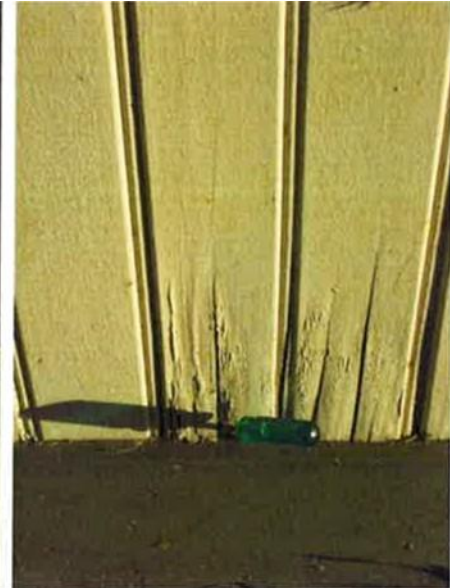
Painted Wood That Has Begun to Rot

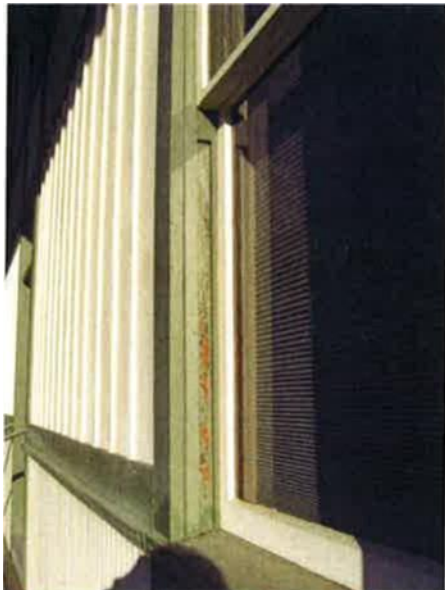
Peeling Paint at Window Jamb

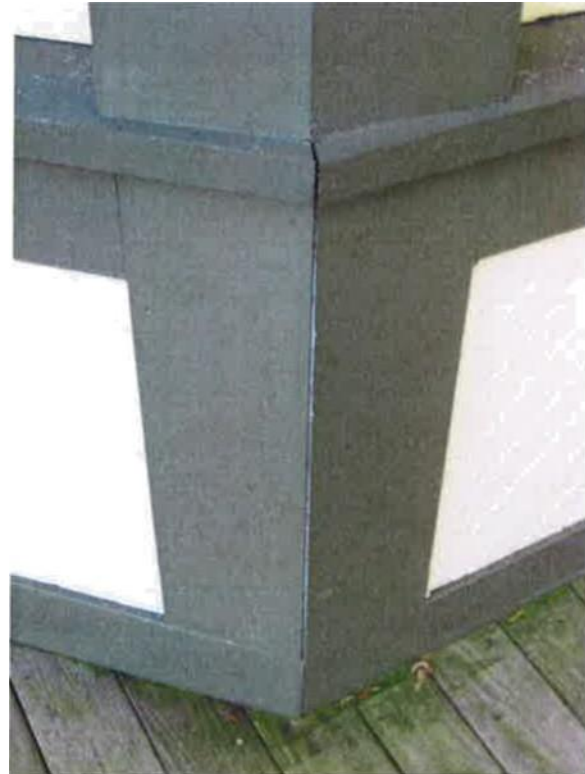
A Joint and Corner Board Trim That Has Opened

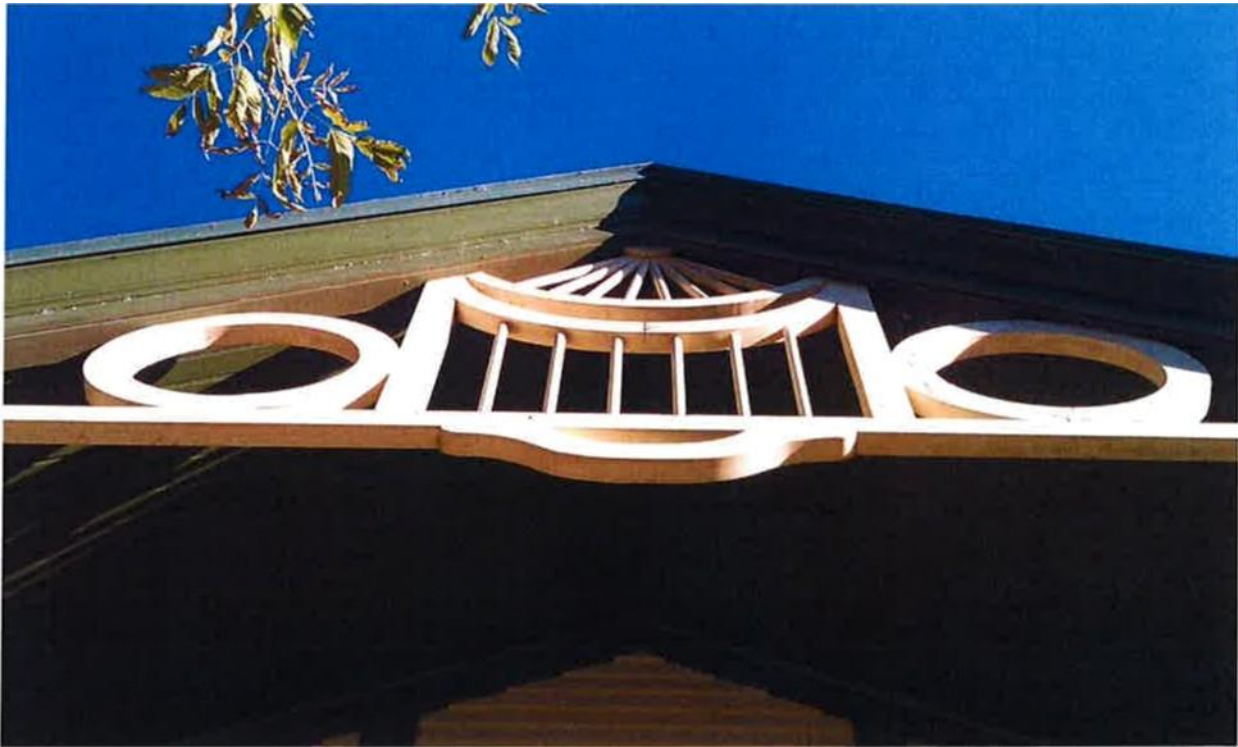
There are a number of joints where corner boards, horizontal trim boards, etc. meet that have begun to open. These joints need to be caulked/sealed to prevent water from entering and getting behind the trim and causing damage. Once water enters, it can cause rot and has allowed in one area for moss to grow. A sign that wood is absorbing water.

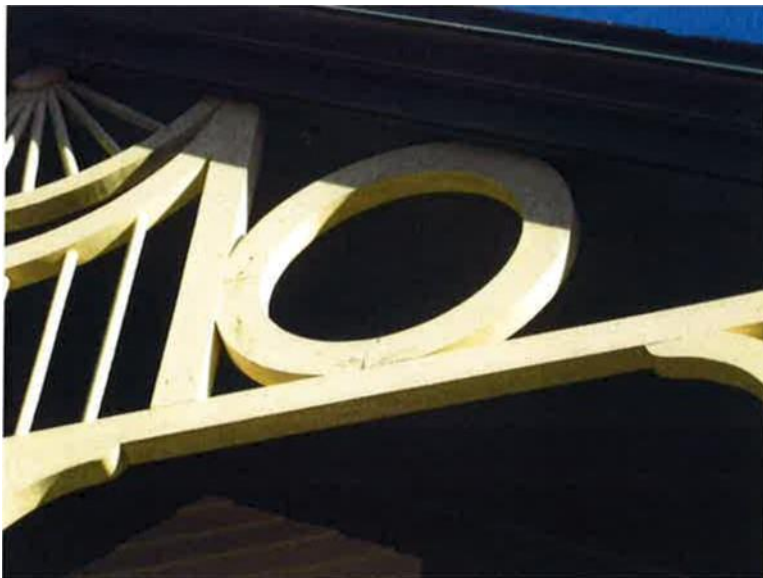
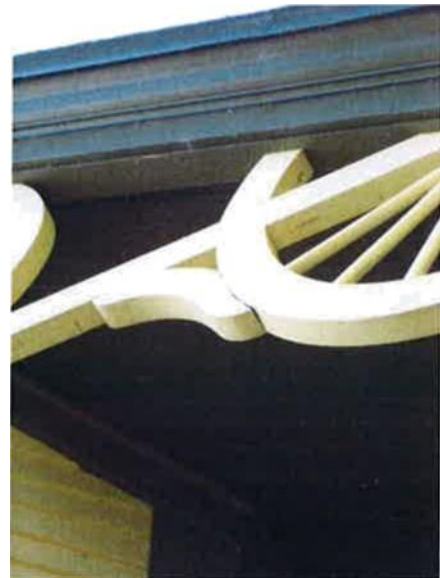
Because of the issues mentioned previously, a repainting/maintenance program needs to be developed to properly maintain the exterior of the building. Paint applied to exterior wood must withstand yearly extremes of both temperature and humidity. It's the only protective coating the exterior of the building has. One of the main causes of wood deterioration is moisture penetration. A primary purpose for painting wood is to exclude such moisture, this slows the deterioration not only of a building's exterior trim and decorative features but, ultimately, it's underlying structural members.
